FINAL EVALUATION REPORT

Project Number	
Project Title	Demonstrating Ecological Mangrove Rehabilitation at Krabi Estuary Ramsar Site, Thailand
Country	Thailand
Selected Year	2007
Implementing Organisation	Wetlands International – Thailand. See Appendix 1 for details
Partner Organisations	Mangrove Action Project Dept Marine & Coastal Resources
Net Res	
Project Duration	2 Years

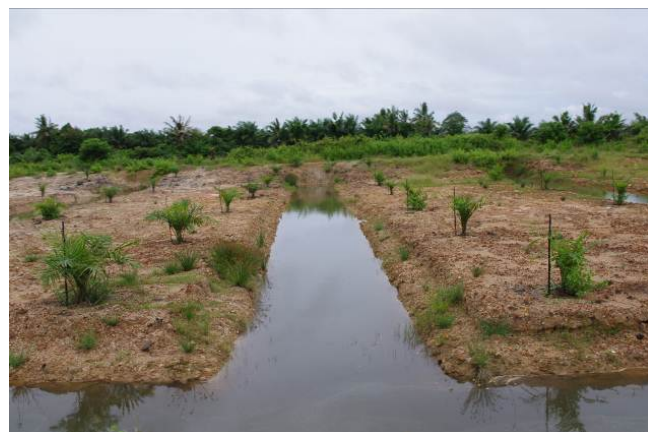
Figure 2. Former mangrove area, converted to aquaculture, and now oil palm, supported by the Land Development Office. Bang Lang Da, Krabi.

A glance at the satellite imagery of the Krabi Ramsar site (see Appendix II) reveals just how extensive the aquaculture industry is, even within a Ramsar site. In southern Thailand there are now extensive areas of abandoned or idle shrimp aquaculture ponds due to problems stated above and/or the poor economics of shrimp farming. In Southeast Asia mangroves continue to be lost at a rate of 1 - 2% annually, while much of the remaining mangrove forest is degraded. Aquaculture pond abandonment in former mangrove areas is a worldwide phenomenon, but given time pond mud walls erode and with luck a pond can naturally regenerate back to mangrove once tidal flushing is re-established. However, in Thailand, the mangrove loss to aquaculture does not stop at pond abandonment, as the Land Development Dept is now encouraging further conversion from former aquaculture pond to oil palm growth (see Figure 2).

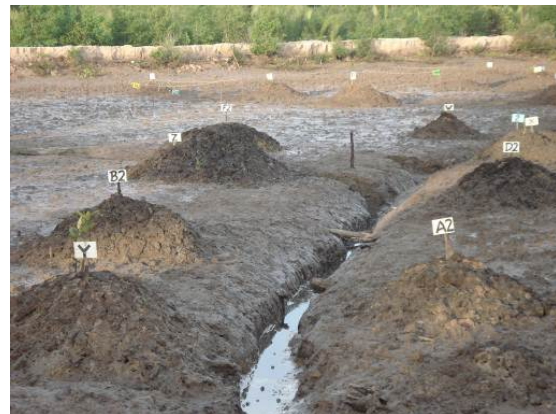
Figure 4. Excavated channel, following original stream to improve hydrology, with labelled hills for mangrove growth and monitoring

The site was labelled as far as possible to aid explanation (see Figure 4). All visitors were accompanied so as the detail of the project and the learning could be disseminated. During tours with visitors and other NGOs interested in mangrove rehabilitation (see Appendix IV), the process of EMR was explained and the

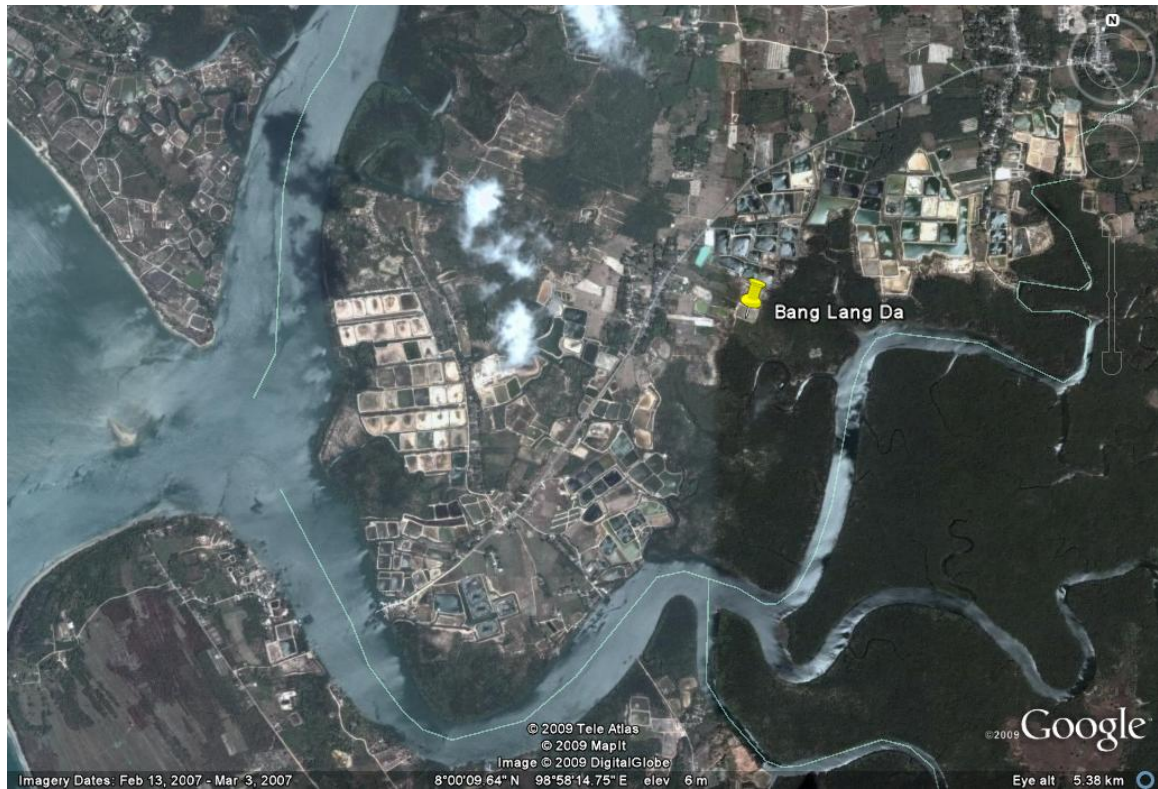
Figure 11. Google Earth image of part of Krabi Estuary, including Project Site (pin)

After considering two other sites, an abandoned 0.7ha aquaculture pond in a former mangrove area in **Ban Lang Da** (BLD) village was found (see Appendix II). Bang Lang Da is the adjacent village to Ban Ta Lin Chan, still in the Krabi Ramsar site.

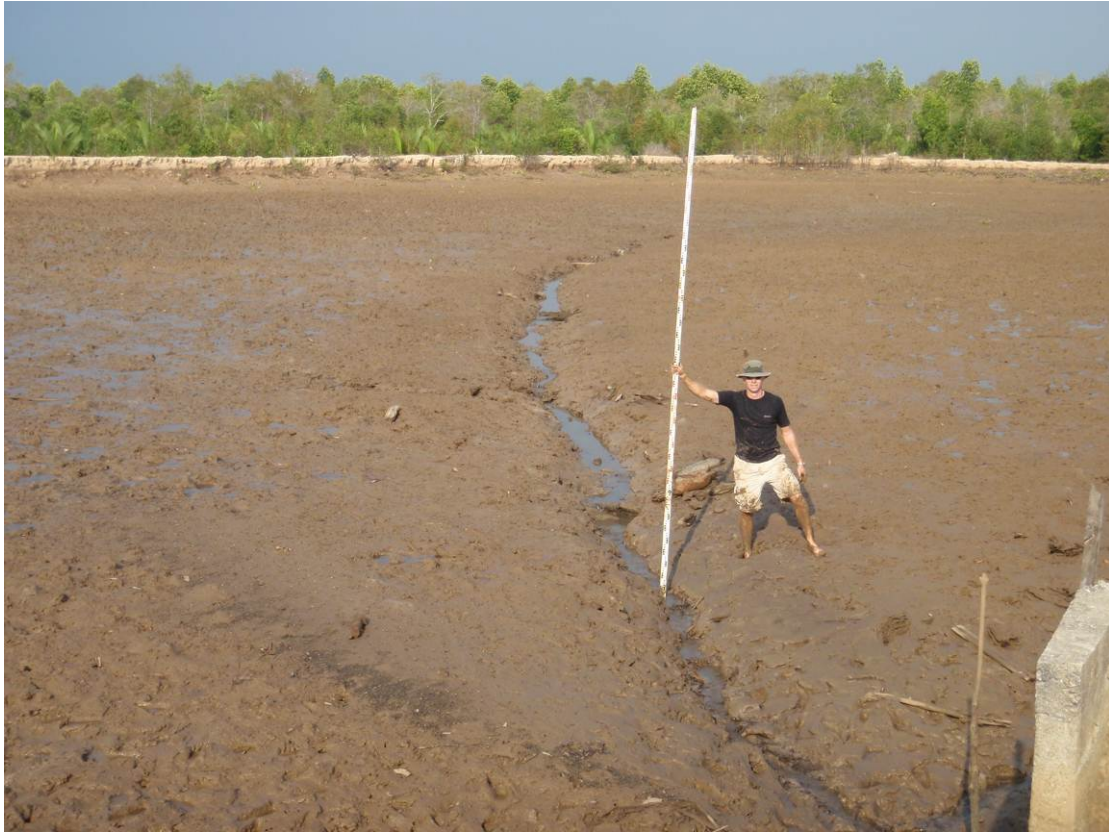
Figure 12. Pond survey, March 2009. Open for 3 years but very little natural regeneration.

This site was chosen as it was a typical aquaculture pond, carved out of former mangroves. The pond had been abandoned for 5-7 years and the mud walls round the blocked sluice gate had eroded, thus allowing tidal flushing for 2-3 years before the project started. However, despite the availability of propagules and seeds, the pond floor was not regenerating (see Figure 12). A site survey supported the hypothesis that the pond was not regenerating due to the substrate being too low, relative to sea level – almost Watsonian (1928) mudflat.

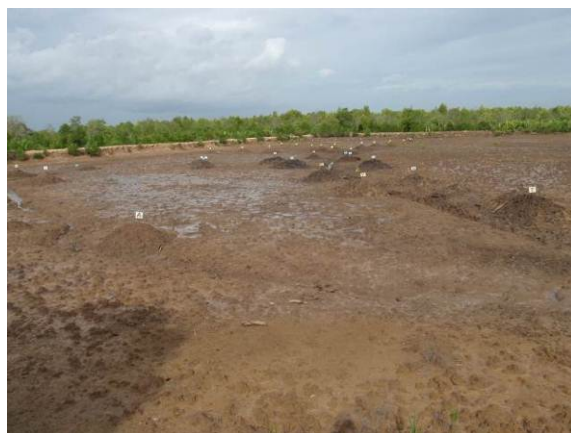
Figure 13. Pond excavations as of Feb 2010

Most of the effort has been focused on repairing the topographical damage - widening and lowering the channels across the pond to improve drainage and with the spoil creating a series of hills, of drier and firmer substrate.

Approximately 32 hills have been dug and 60m of channel improved or dug. Each of the hills is about 1m high by 3m across, weighing about a tonne. This has provided more substrate at the appropriate height for mangrove growth and better drained soil. Many of these hills have quickly been colonised by crabs.

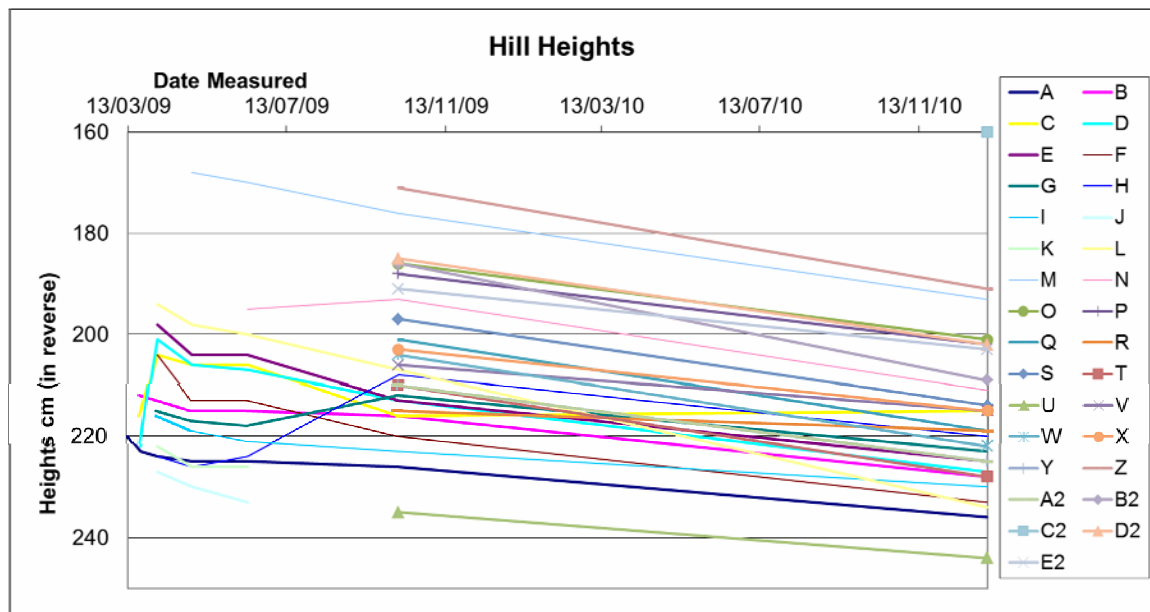
Figure 14. Hill heights over time, March 2009 – Jan 2011

Despite misgivings by local people, once settled, and water squeezed out of the clay by its own weight, the hills remained relatively stable (see Figure 14) losing between 10-20cms height over 18 months. For example, Hill A, the first hill produced, has settled and lost only 16cms in height, between March 2009 and Jan 2011. Though the sample is small, vegetated hills seemed to be more resistant to erosion, possibly from the protection the leaves offer from the rain.

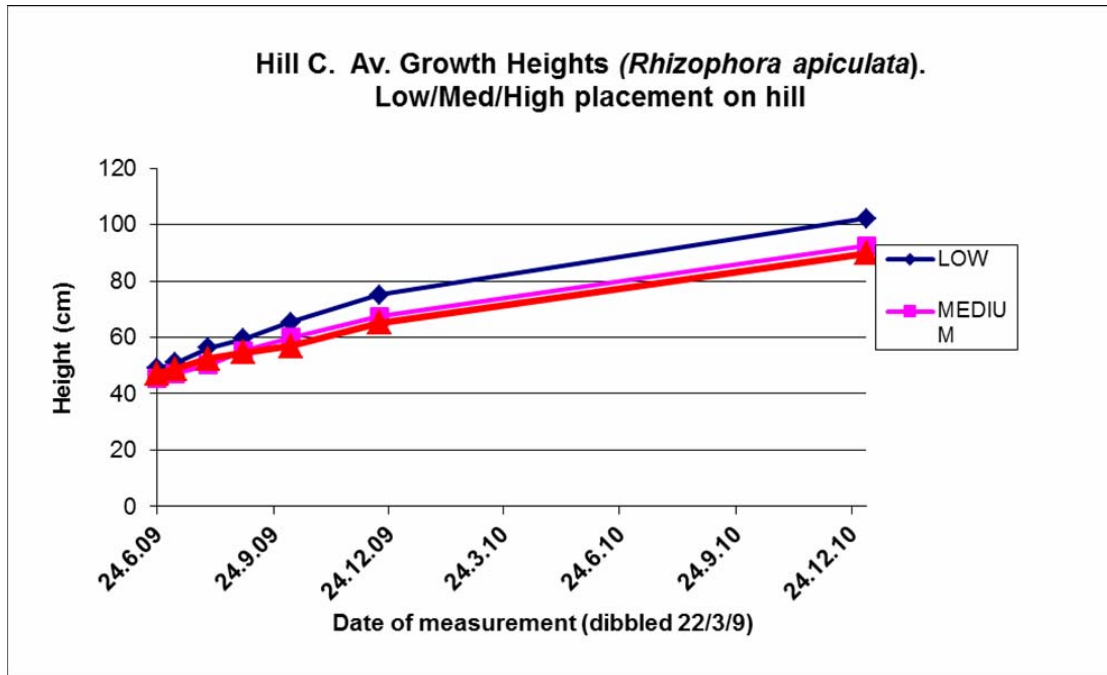
Figure 15. Plant growth on Hill C (*Rhizophora apiculata*)

Figure 15 and Figure 16 below shows Hill C's encouraging and continued growth.

Figure 15 also shows that though propagules were dibbled around the base of the **hill**, **mid-way** up and on **top** of the hill, the heights attained by the surviving plants suggest that lower plants were slightly taller than the higher and mid-level plants.

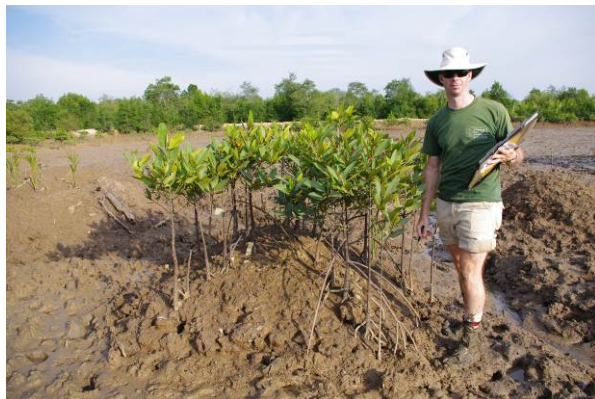
Figure 16. Hill C, Jan 2011, 22 months after dibbling

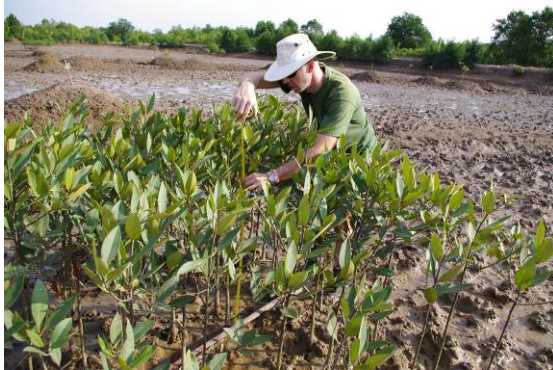
Figure 17. Test Plot 1. *R. apiculata*. Jan 2011

Initially, the TP plants struggled up quickly to gain more height, at the expense of far fewer leaves, and leaves that were 50% of the size of those on Hill C. However, almost two years after the event, the leaf size difference has largely gone. Similarly, TP1 average height is 100cm (see Figure 17) and TP2 110cm to Hill C’s 95cm average, so now all about similar height.

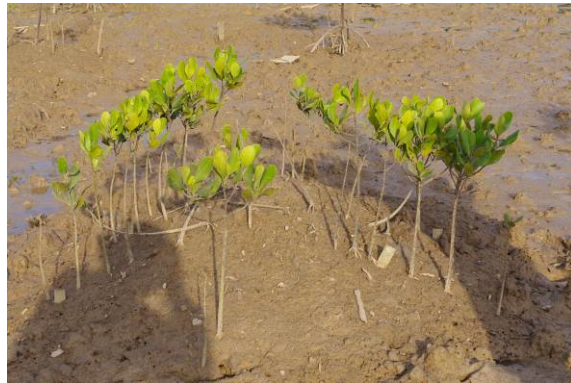
Figure 18. Hill E. *Ceriops* missing from the top, but surviving around the base. Jan 2011.

Of constant concern was debris that floated into the pond from the outside. Hills E and L appeared to have sustained impact damage, and the tops of both hills had been cleared of dibbled plants, but the plants lower down the slopes surviving (see Figure 18). There was a lot of debris in the corner of the pond, and occasionally with a high tide and change of wind direction, this

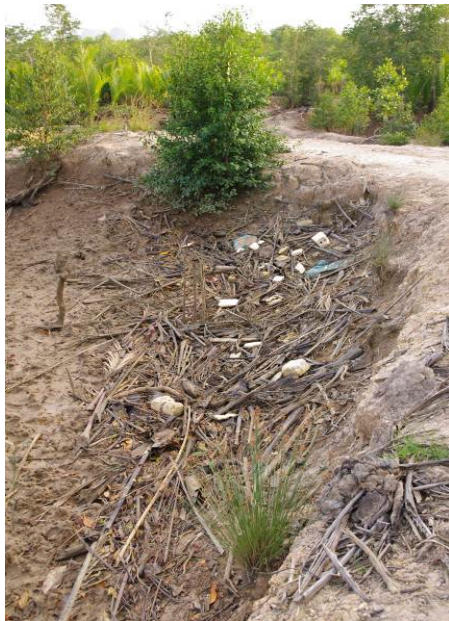
Figure 19. Debris that had drifted into pond, Jan 2011. Largely *Nypa* palm midribs.

would shift to the other end (see Figure 19). It is suggested that this movement, and debris in general, killed off some of the plans, and also reduced the amount of successful natural regeneration within the pond.

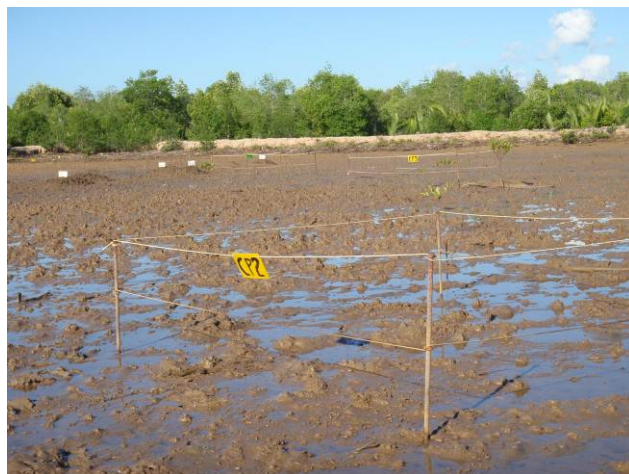
Figure 20. Control Plot 2. 3x3m. 7 in total. Picture 2009

Seven 3x3m Control Plots were installed over the pond to monitor natural regeneration on the pond floor. Though the rods demarking the plots were eventually stolen, the plots remained empty.

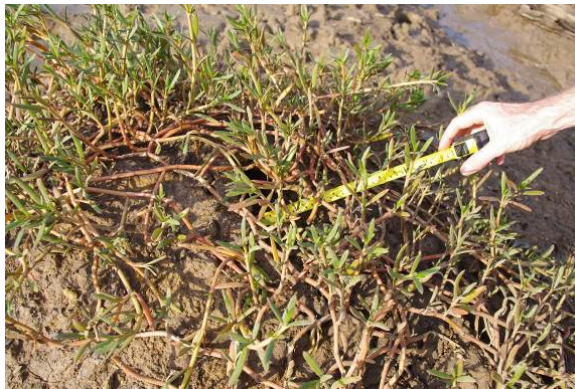
Figure 21. Hill E2 Jan 2011. Dibbled with *Sesuvium*, growing vigorously. Dibbled Oct 2009

Only one *Xylocarpus moluccensis* arrived on a hill (C) and set root. It is suggested that once a hill is produced, rain and inundation erode the hills' creviced surface, and in combination with a baking sun, produce smooth hard hills, which the seeds just cannot stick to. Sadly only one hill (E2, see Figure 21) was dibbled with *Sesuvium*, which might help to trap seeds as they float past, but as of Jan 2011 no species had taken hold within the *Sesuvium*.
