Progress Report on  
**ECOLOGICAL MANGROVE RESTORATION PROJECT**  
IN THE AYEYARWADY DELTA, MYANMAR

**PROGRESS REPORT ON  
ECOLOGICAL MANGROVE RESTORATION PROJECT  
IN THE AYEYARWADY DELTA**

Prepared by  
Mangrove Service Network - MSN  
YANGON, MYANMAR  
30 June 2006

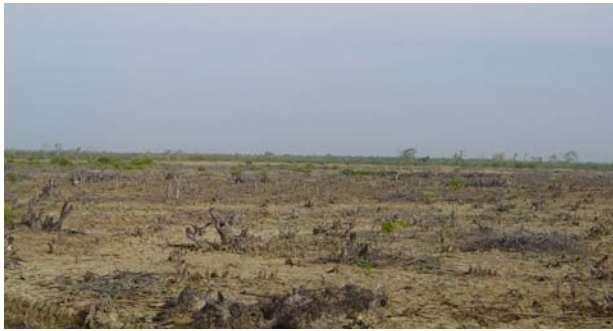
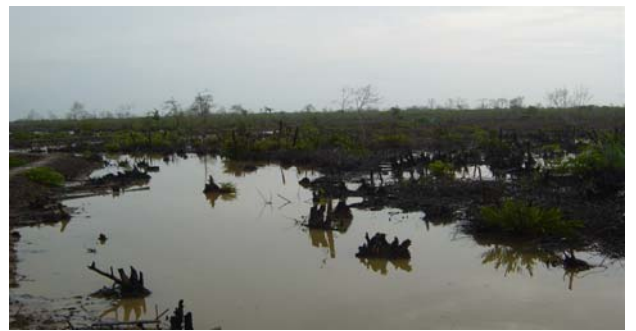
Mangrove Forest in the project area were degraded due to encroachment of shrimp ponds
