Mangrove Restoration Impact Assessment Report in the Bay of Jiquilisco

Feb 2023

Mangrove Restoration Assessment

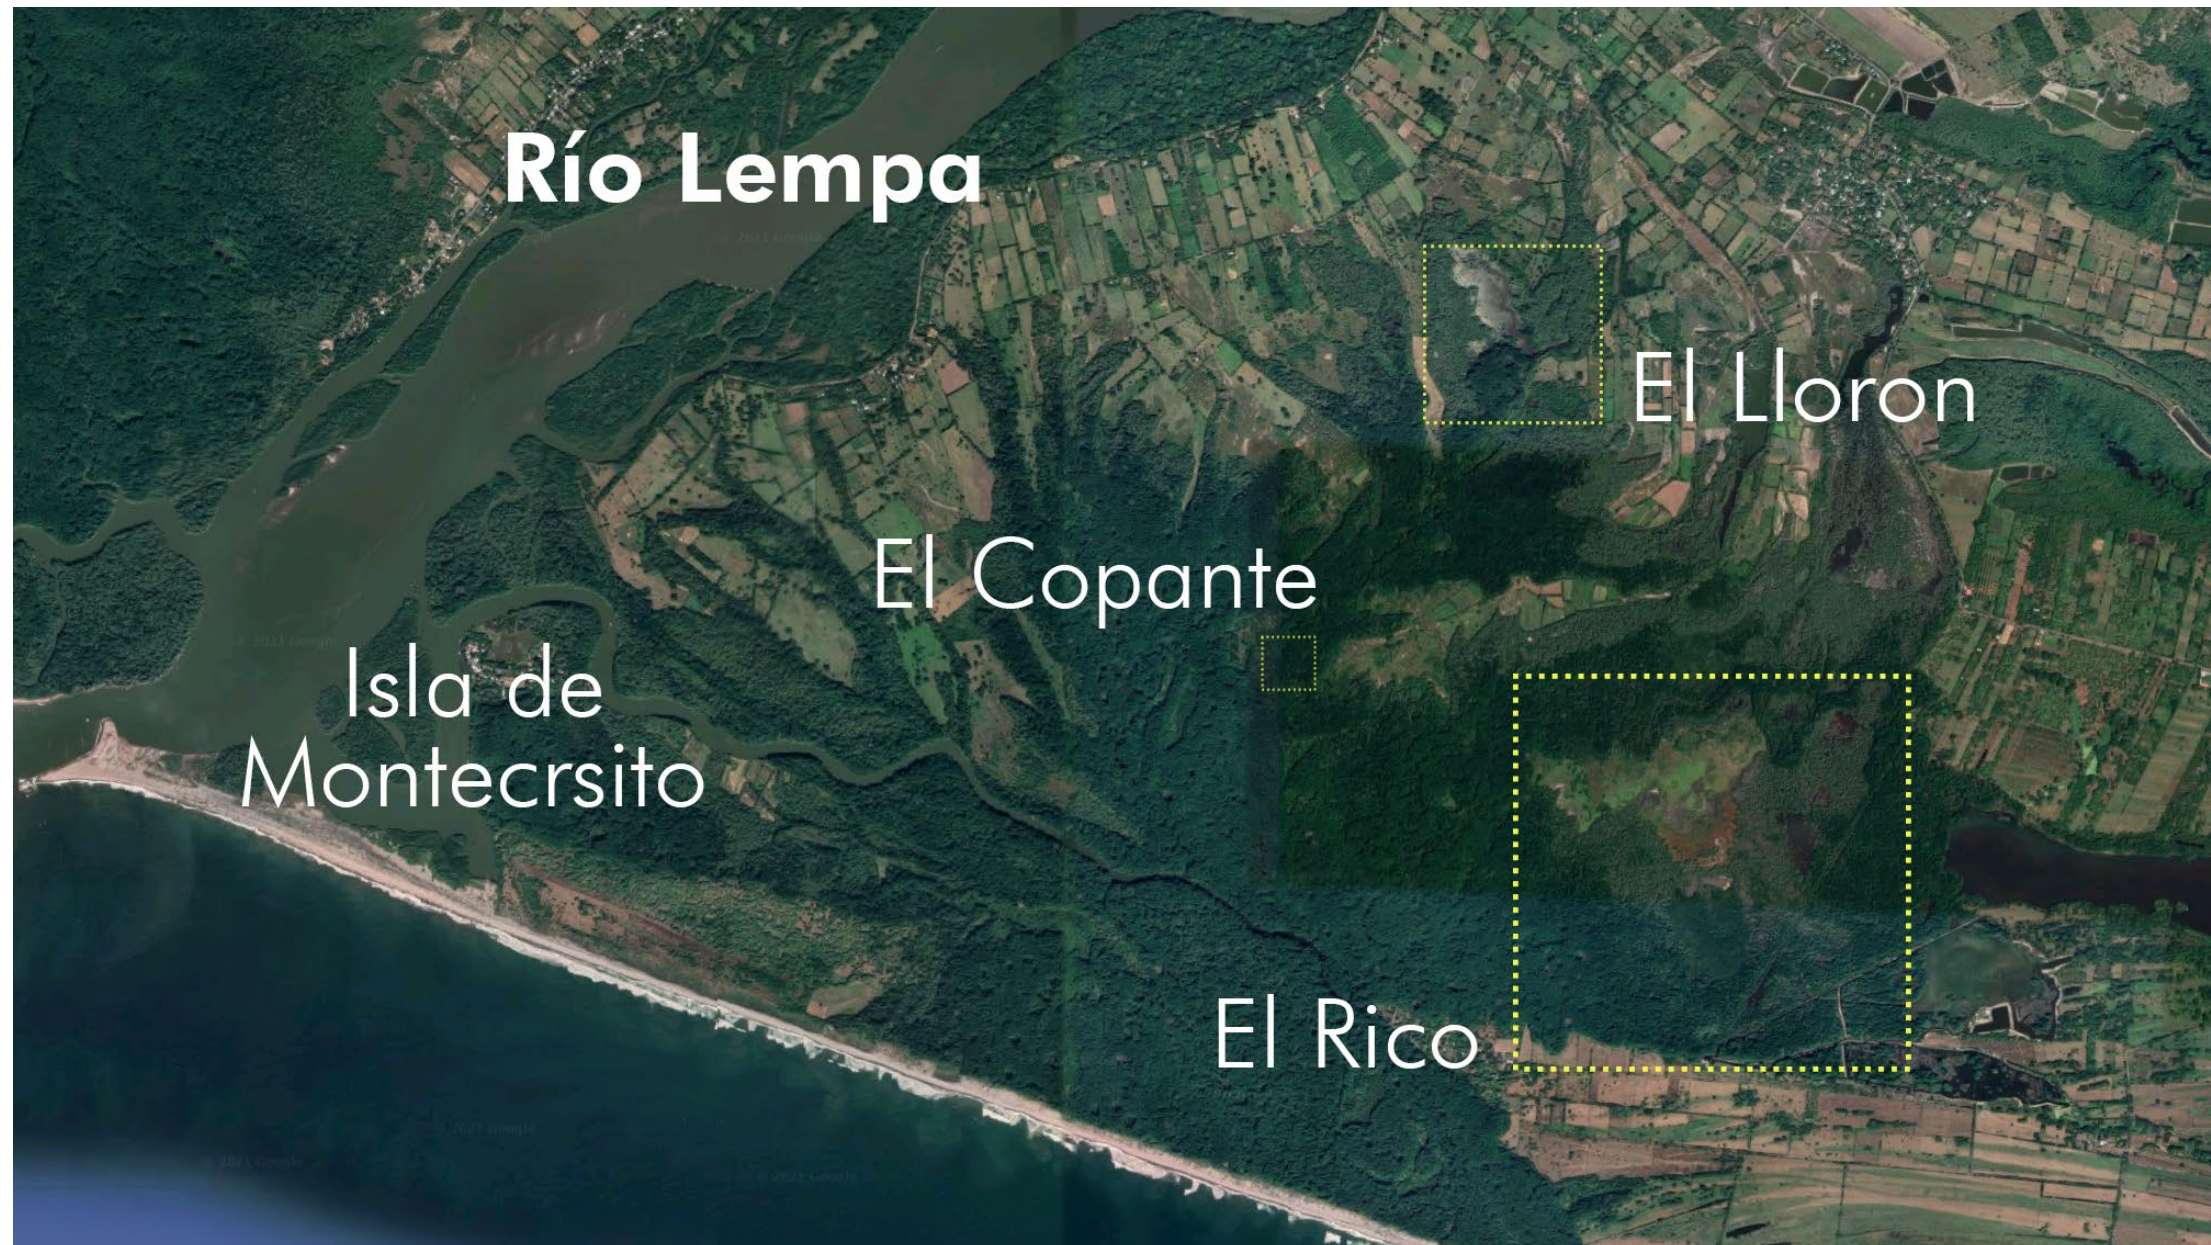
Extent and change of vegetation cover in the project areas

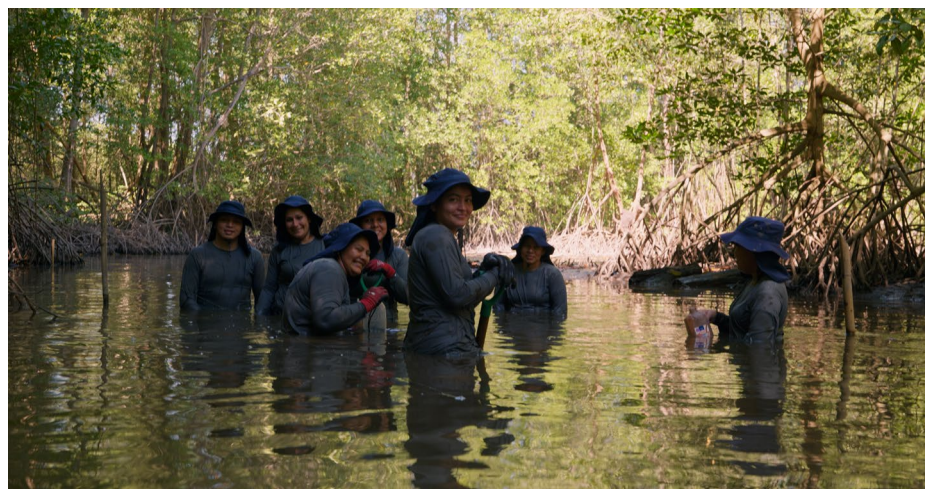
Community members like Wendy Ramos from La Chacastera dig and collect mud to maintain the channels in El Llorón channel. Half the restoration team are made up of women.

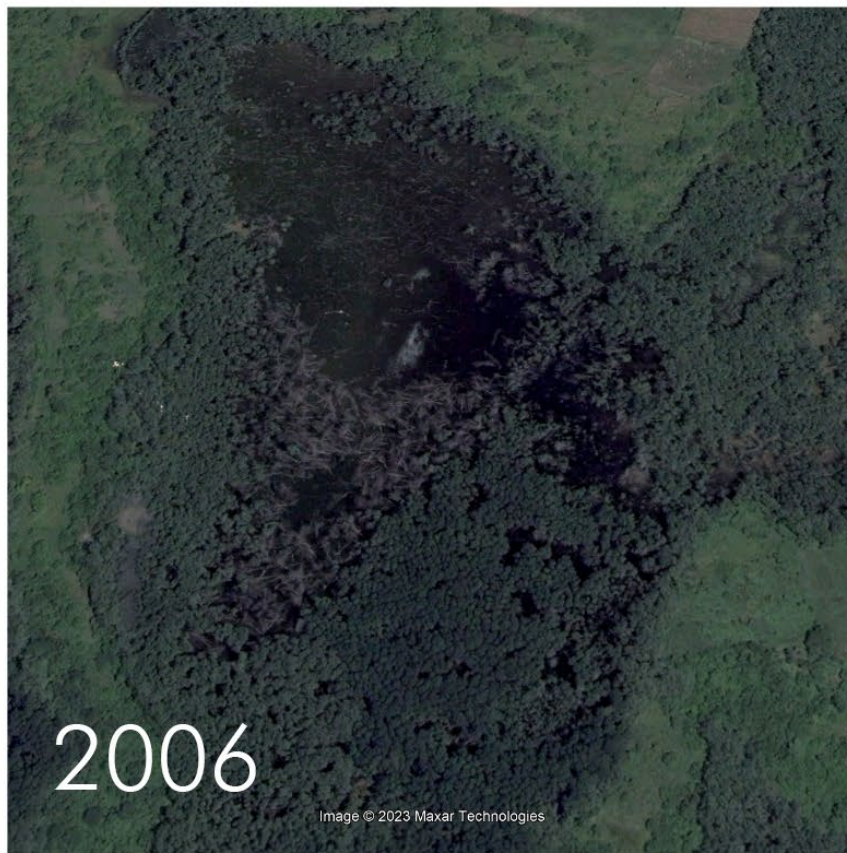
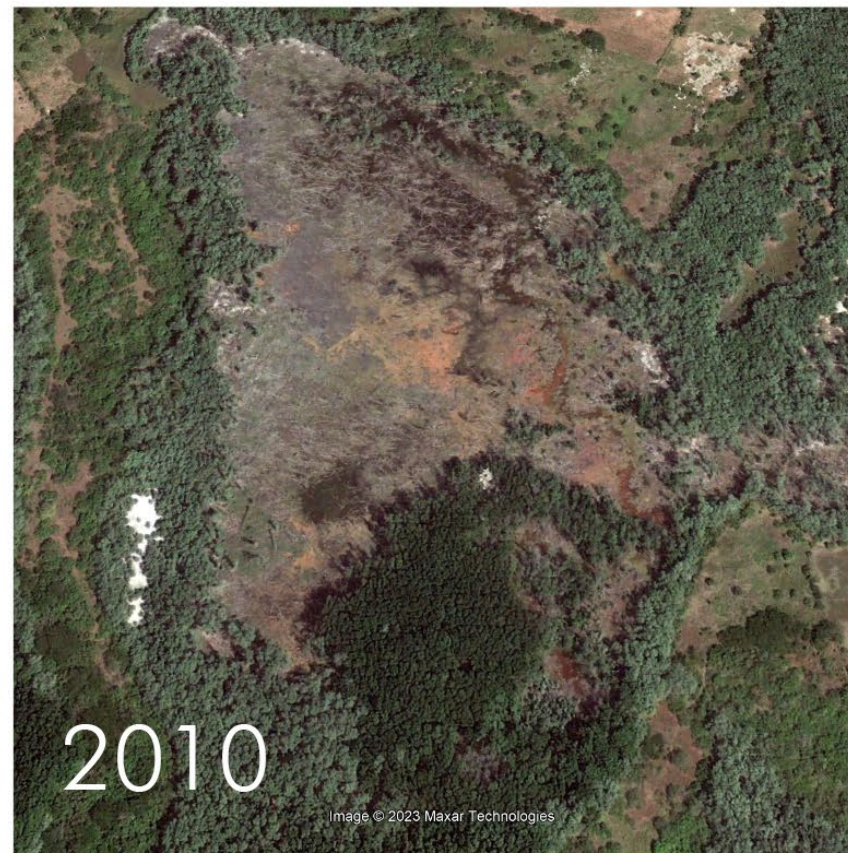
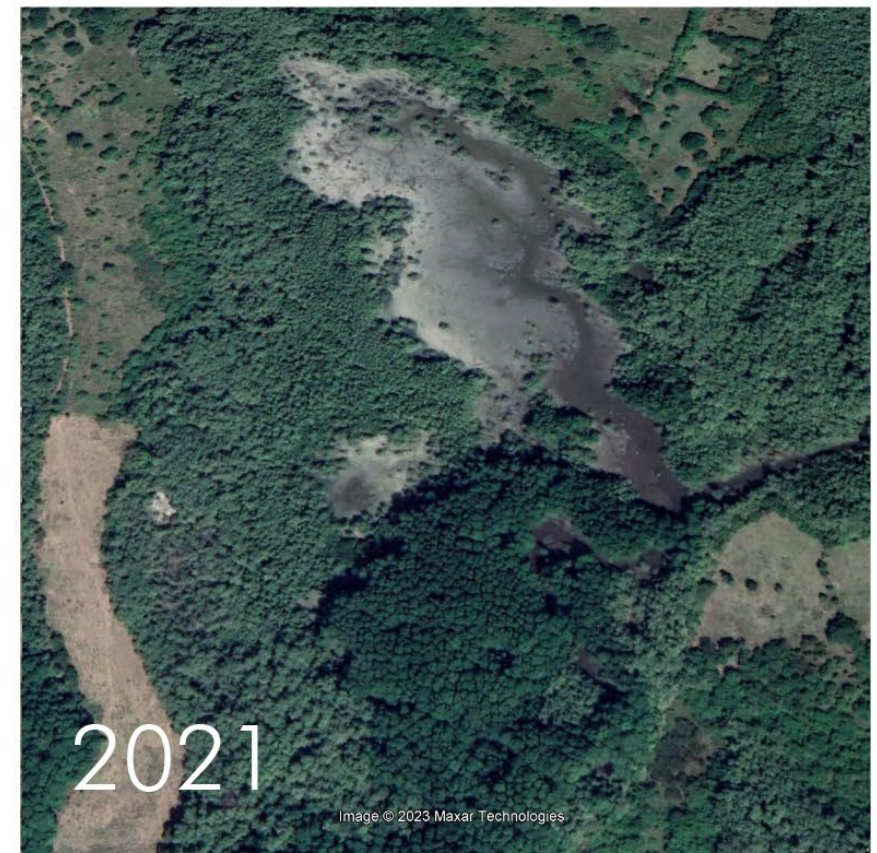
Recovery From Above

Aerial images showing the restoration of 'El Lloron' mangrove area using Ecological Mangrove Restoration techniques.

By looking at historical and current mangrove presence on Google Earth Pro, the area of mangrove trees around the channels at El Lloron has increased by 18.7 hectares.

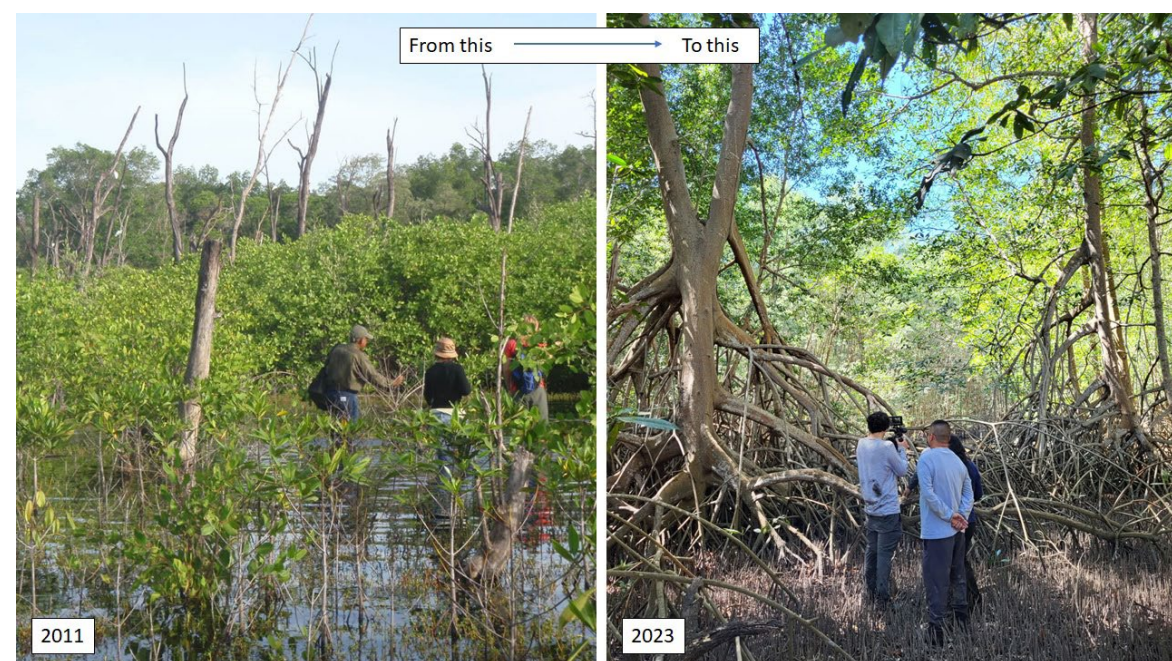
The hydrology has improved which has seen an increase in tidal flushing and there are no longer deep areas of standing water. Environmental conditions were collected (salinity, pH and soil type) which all point to healthy restored ecosystems. significant increase.

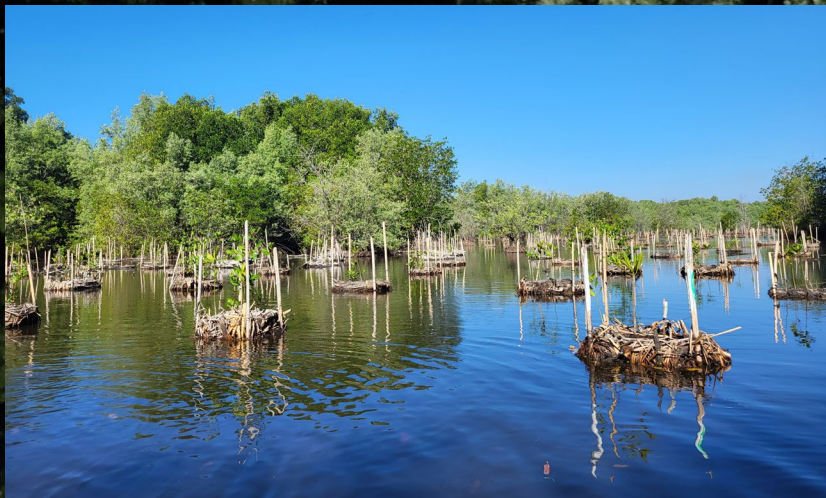
CHINAMPAS*

The MAP team met with Alejandra from HALO Trust and heard about the work they are doing at El Lloron to build chinampas. The chinampas are islands of mud, reed grass and bamboo, which allows mangroves to grow where the substrate elevation is too low to support mangrove growth. This area is permanently inundated.. The project provides employment for community members and at-risk youth to work alongside HALO's team.

There are 300 chinampas, made with four bamboo stakes and woven reed grass, which is then filled in with sediment from the surrounding area. All chinampas have been planted with 4 – 5 seedlings, a mixture of the three existing species – red mangrove, black mangrove, and white mangrove. They are being monitored every two months to see which species survive, to check for elevation changes, and to record environmental conditions.

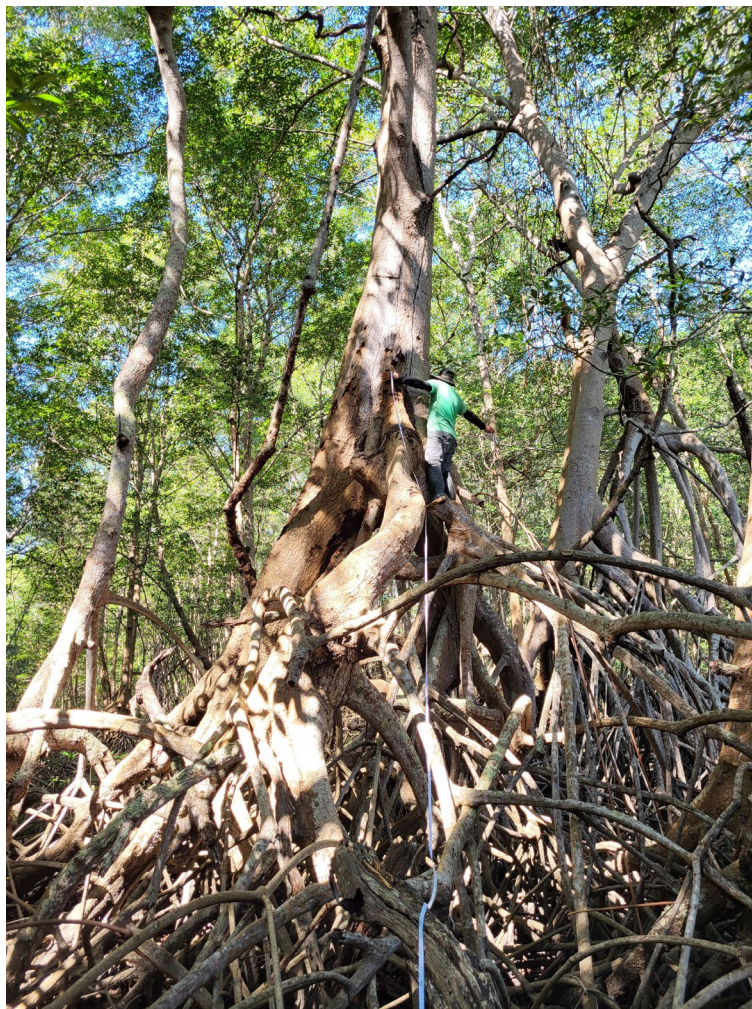
One of the tallest *Rhizophora* trees we surveyed in El Rico.

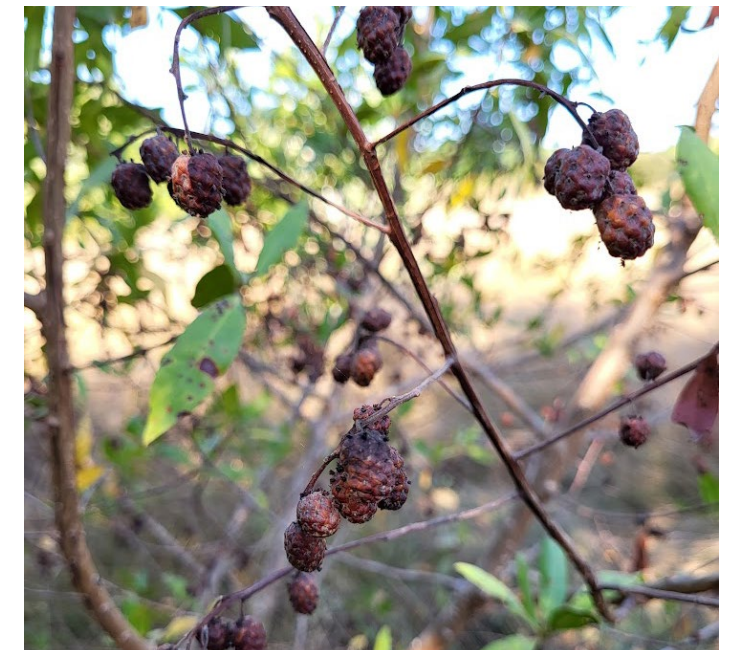
The four original tree species have returned to El Rico, red mangrove (*Rhizophora racemosa*), black mangrove (*Avicennia germinans*), white mangrove (*Laguncularia racemosa*), and buttonwood mangrove (*Conocarpus erectus*) a mangrove associated species. The hydrology has improved and there are no longer areas of standing water. The areas of restored mangrove are of relatively high elevation, on the landward edge of the mangroves, and some of the quadrats included terrestrial grasses. Environmental conditions were collected (salinity, pH and soil type) which all point to healthy restored ecosystems.

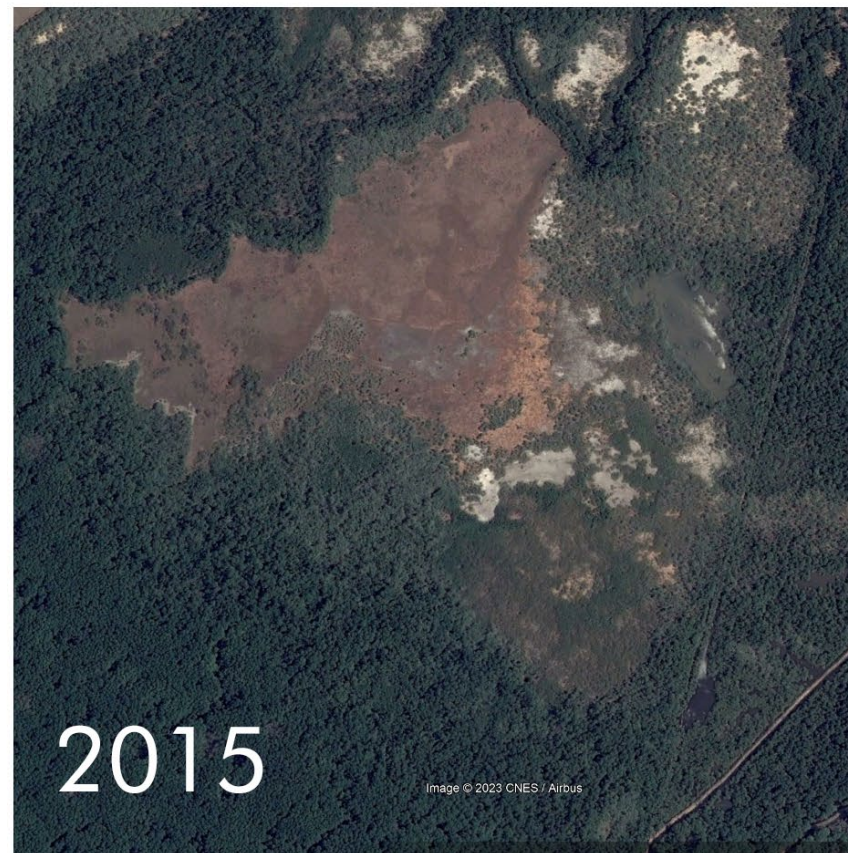
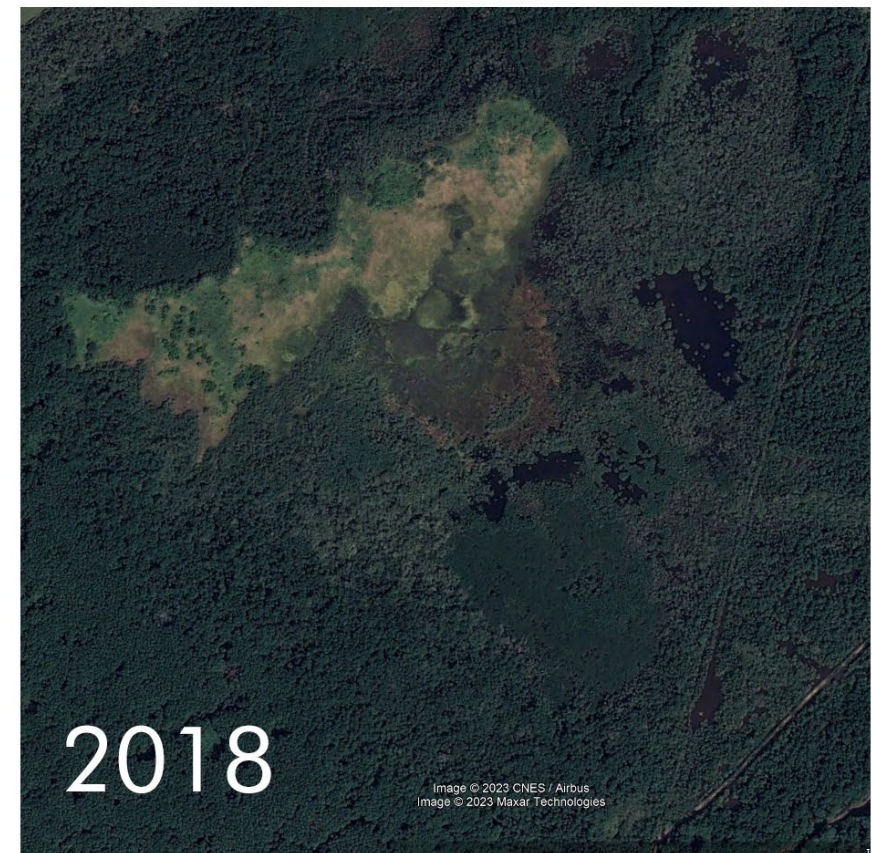
Recovery From Above

Aerial images showing the restoration of 'El Rico' mangrove area using Ecological Mangrove Restoration techniques.

By looking at historical and current mangrove presence on Google Earth Pro, the area of mangrove trees around the channels at El Rico has increased by 34.2 hectares.

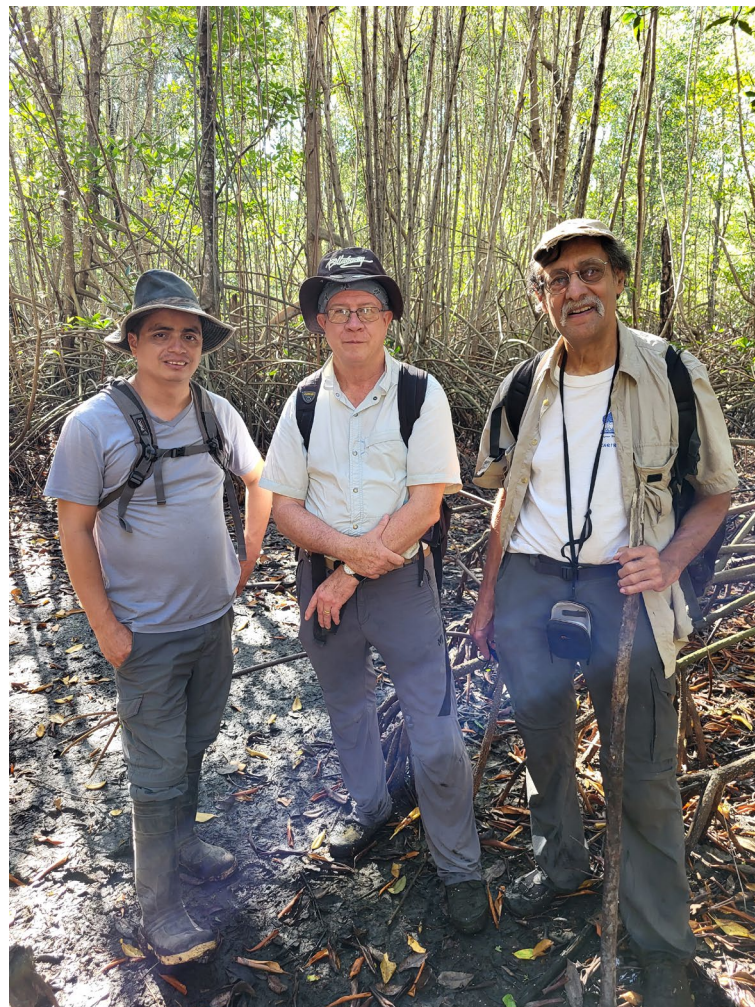
When Jim Enright and Alfredo Quarto last visited this site in 2011, the mangroves were extremely stressed with standing water.

A new 2 km channel was excavated to connect the site to existing canals, which allowed the standing water to drain from the area. Once connected to the tidal cycle, the movement of water brought many mangrove seeds and natural regeneration occurred.

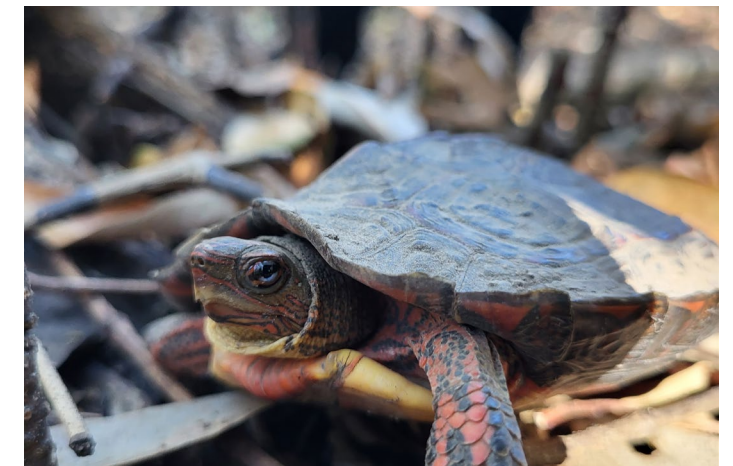
The three original tree species have returned to El Copante, red mangrove (*Rhizophora racemosa*), black mangrove (*Avicennia germinans*), and white mangrove (*Laguncularia racemosa*). The majority of the restored area surrounds the new channel and has a high density of trees, the majority of which are white mangrove (58.2%). The mangrove area at the highest elevation is rarely covered by the tide and floods in the rainy season, this area is home to Jaguarundi, racoons and mangrove terrapins. Environmental conditions were collected (salinity, pH and soil type) which all point to healthy restored ecosystems.

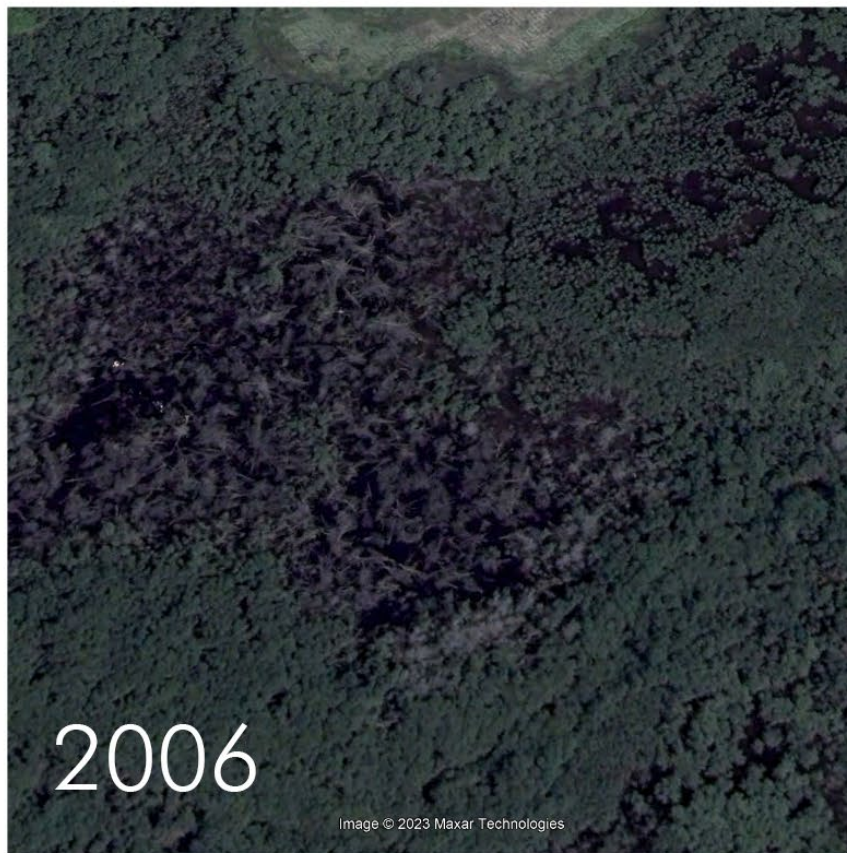
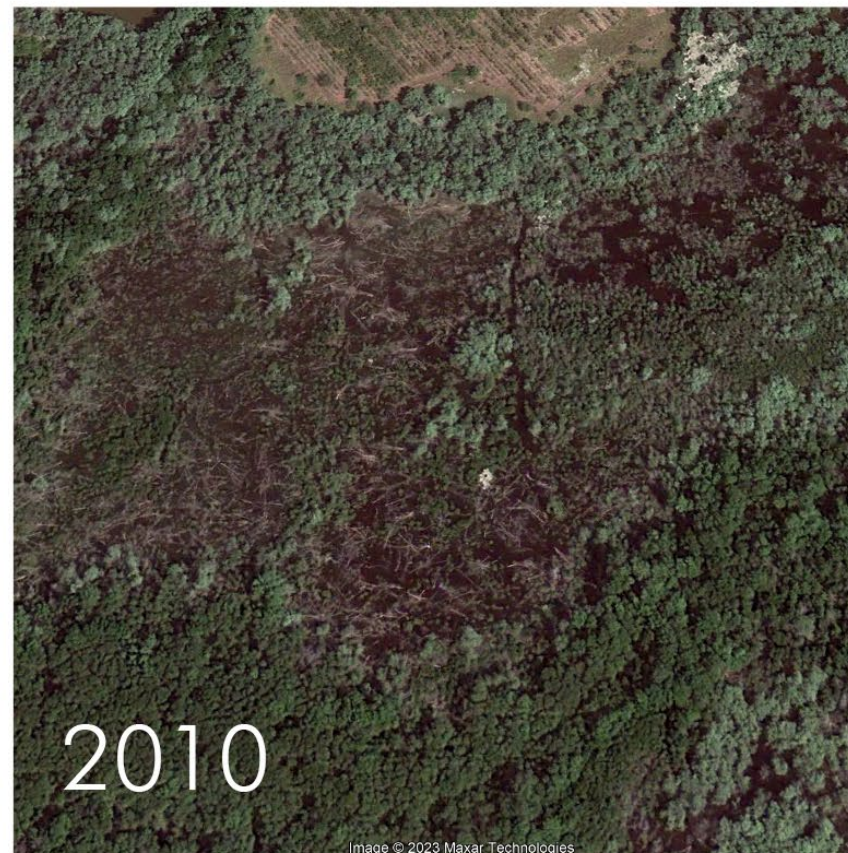
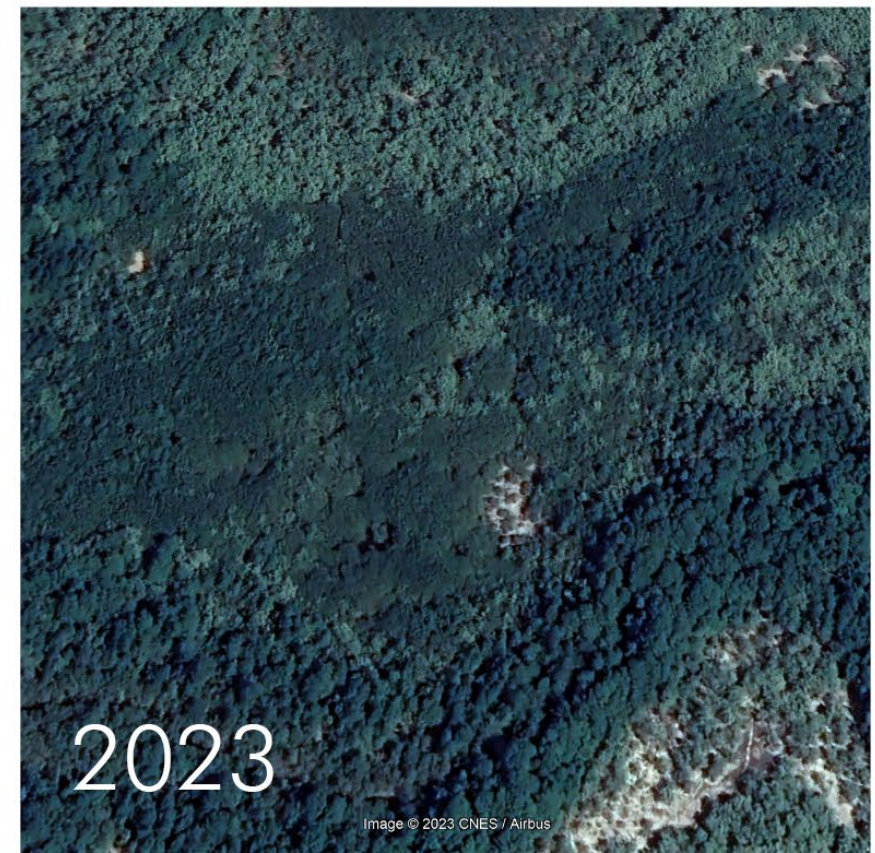
Recovery From Above

Aerial images showing the restoration of 'El Copante' mangrove area using Ecological Mangrove Restoration techniques.

By looking at historical and current mangrove presence on Google Earth Pro, the area of mangrove trees around the channels at El Copante has increased by 8.7 hectares.

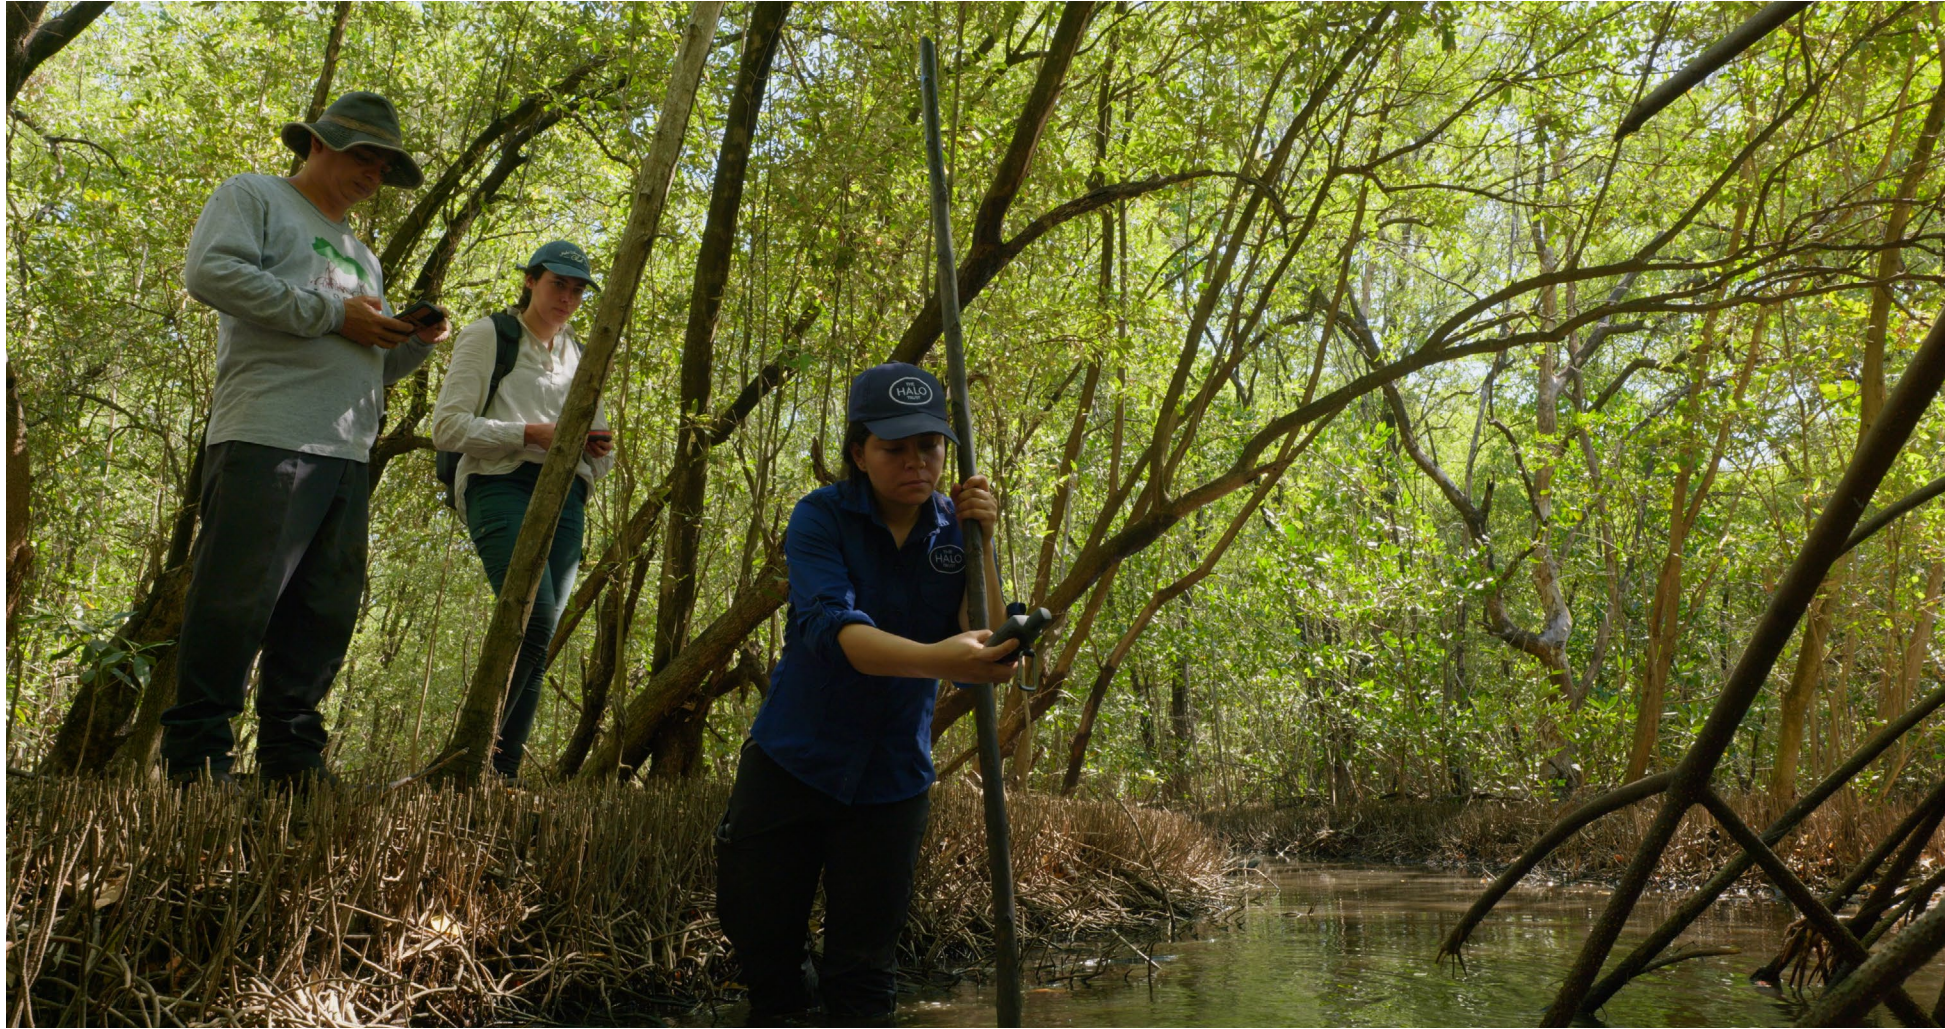
Data was gathered along the 2km channel that helped to restore the mangroves at El Copante.
